## 2021 Year-End Report

### FOREST FIRE LOOKOUT ASSOCIATION

Northwest Montana Lookout Association (NWMTLA) – Local Chapter  
MONTANA / IDAHO NORTH CHAPTER

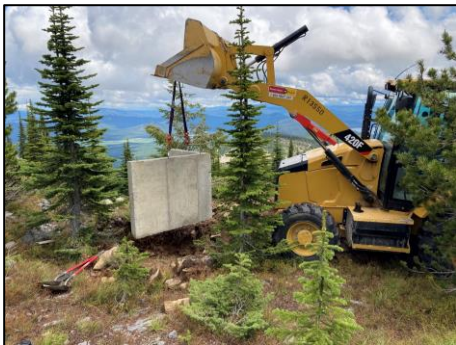
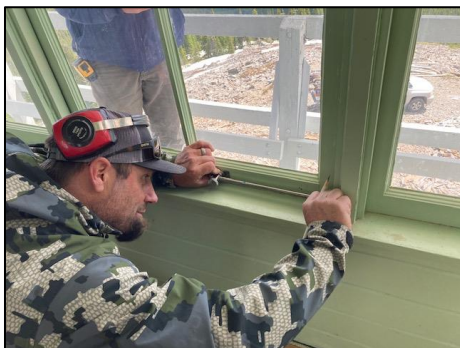
**Meadow Peak Lookout Wrap-up - Kootenai National Forest** – Throughout the spring and early summer, the NWMTLA helped the Libby Ranger District put finishing touches on Meadow Peak Lookout in preparation for it being placed in the Recreation.gov program. Tasks included, but not limited to, attaching safety screen on the railing, making windows operable to allow for cross ventilation, digging an outhouse hole and installing a vault for a privy with a view. Total in-kind value to Ranger District was over \$6,400.

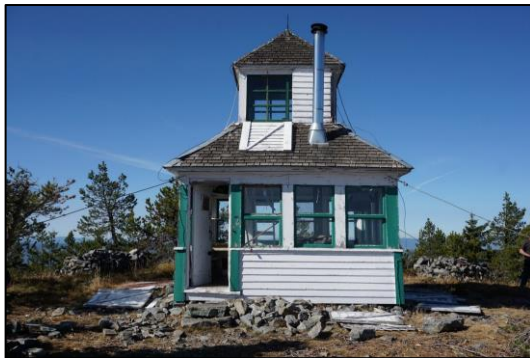
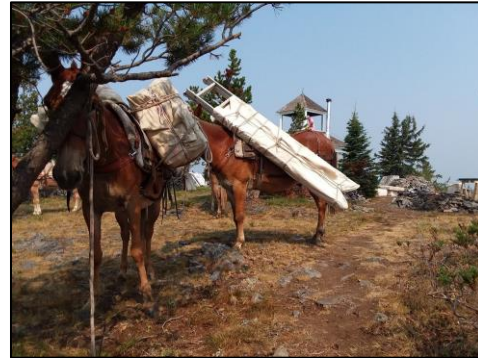
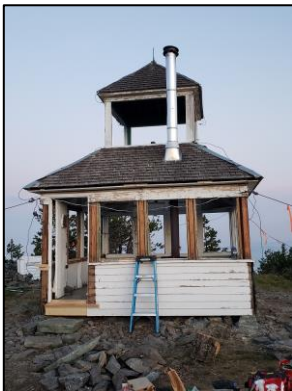
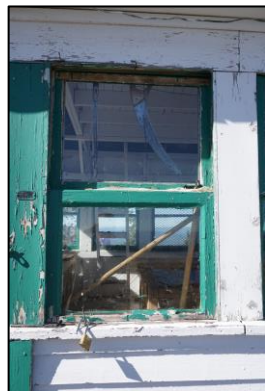
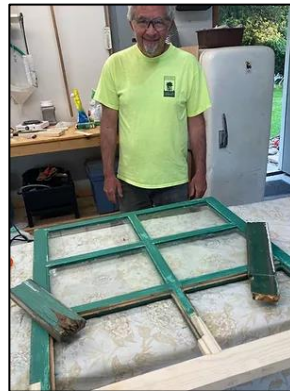
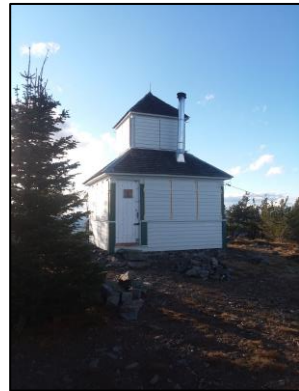
**McGuire Mountain Lookout Restoration Project - Kootenai National Forest** – This project was a Forest Service Resource Advisory (RAC) funded project. Starting in mid-June, the windows were removed and transported to an off-site location to be completely refurbished and in August packed back up to the lookout to be reinstalled. During the month of July, the structure was squared and leveled, window sills, soffit, fascia, and corner trim were repaired/replaced as needed. The entire structure was painted inside and out. Total project value including RAC funding exceeded \$60,000.

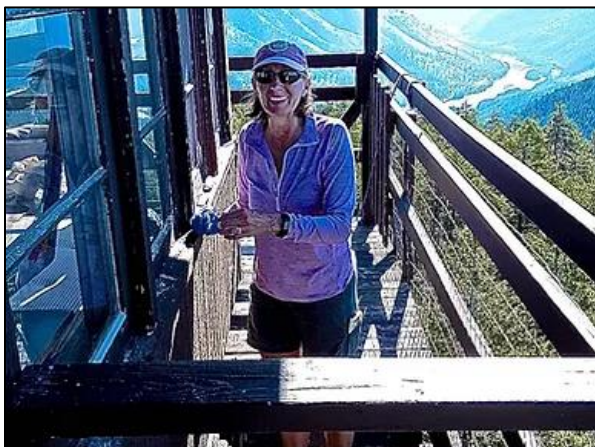
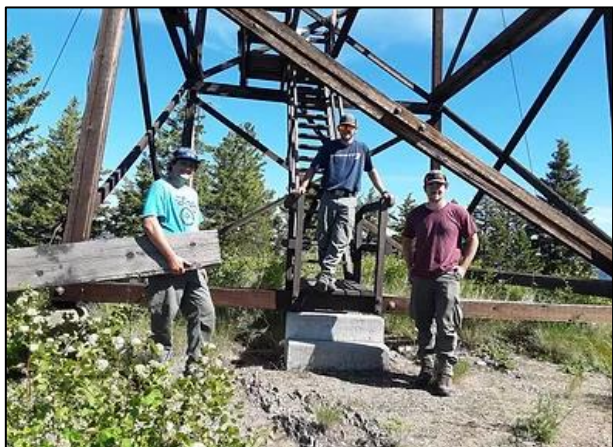
**(Big) Swede Lookout Project - Kootenai National Forest** – This project was divided into two parts. The first part consisted of volunteers glazing 52 windows, replacing catwalk posts, railing, and landing posts. The second project consisted of scraping, sanding and painting the lookout. In 2019 a new roof was put on and additional stabilizing of the roof in 2020.

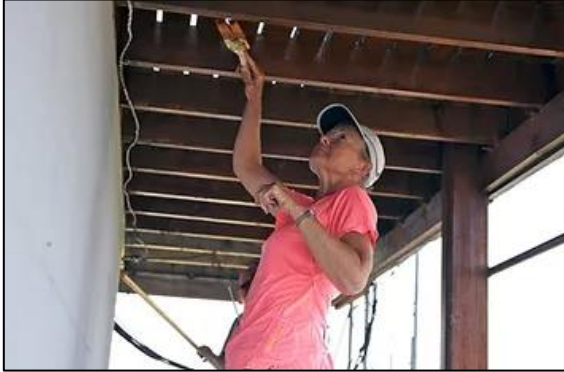
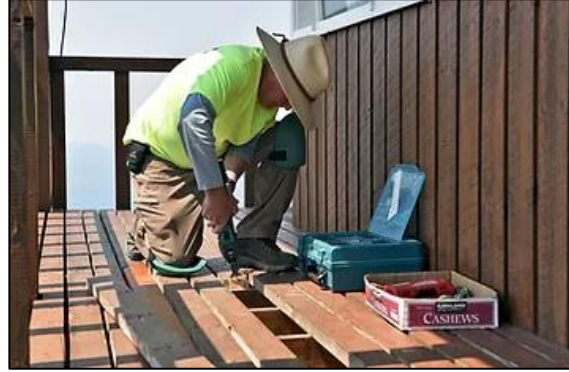
**Werner Peak Lookout Project - Montana Department of Natural Resources and Conservation**

Two phases of the Werner Lookout project consisted of: finishing the painting of the catwalk, railing and window trim plus touchup; and second, digging a hole and installing a vault.

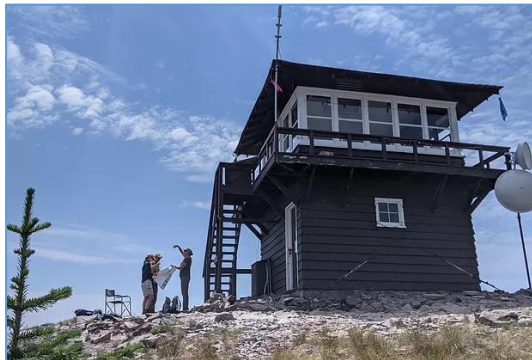
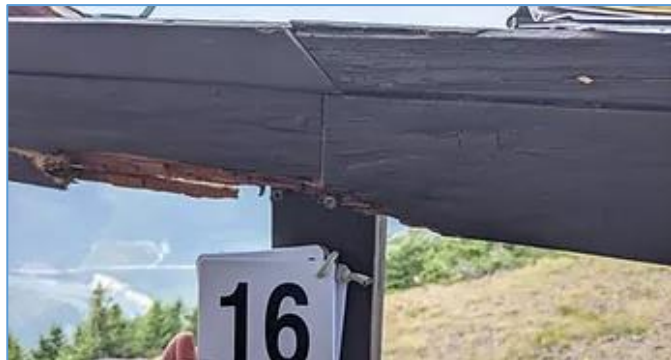
**Huckleberry Lookout Condition Assessment - Glacier National Park**

The assessment identified need for future maintenance including dry rot, window reglazing, cracked exterior boards, failing catwalk railing, and painting. Huckleberry Lookout is a 14'x14' wood structure but of a second design with the hip roof extended to cover the catwalk. The basic design differs from Forest Service L-4s in that the shutters are removable and do not fold up for shading. An original cupola lookout on the site was replaced by this structure in 1933.

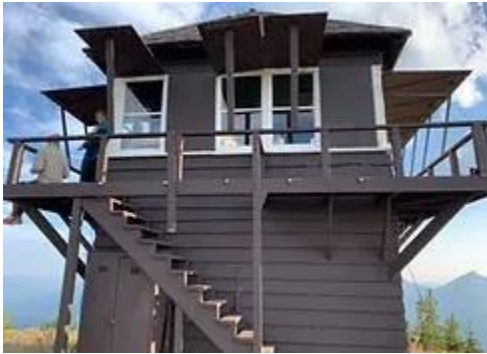
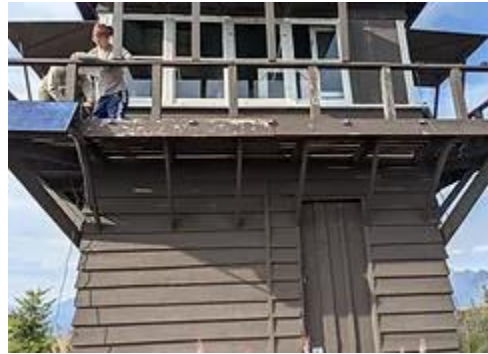
**Loneman Lookout Condition Assessment – Glacier National Park** - Loneman Lookout is a standard wood frame, 14x14-ft. house set on a 10-ft. enclosed tower with catwalk. The condition assessment was conducted over a two-day period. Loneman lookout was found to be in good condition with only minor maintenance issues to be addressed.

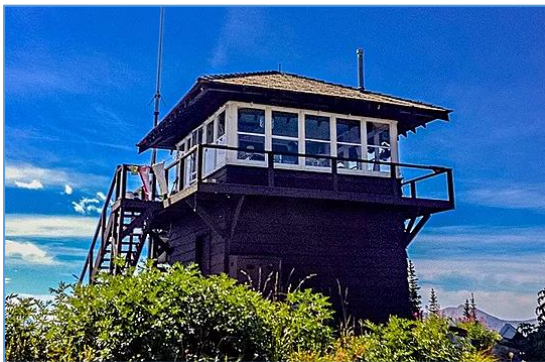
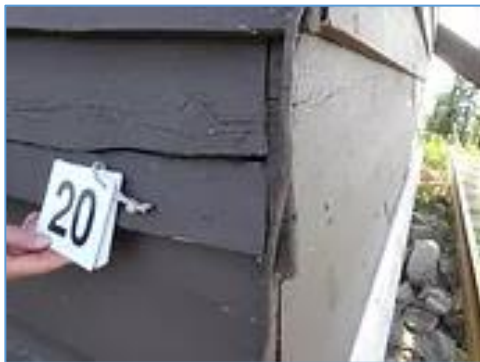
**Scalplack Lookout Condition Assessment – Glacier National Park** - Scalplack Lookout was found to be in good condition with only minor maintenance items noted as it is staffed and maintained during the fire season. Scalplack is a standard wood frame, 14x14-ft. house set on a 10-ft. enclosed tower with catwalk.
